Preliminary Assessment/Visual Site inspection report Re: AC Rochester Division, Davison Engineering

General Motors Corporation 1601 North Averill Avenue Flint, Michigan MID 980 568 620

Technical Enforcement Support at Hazardous Waste Sites Zone III Regions 5,6, and 7

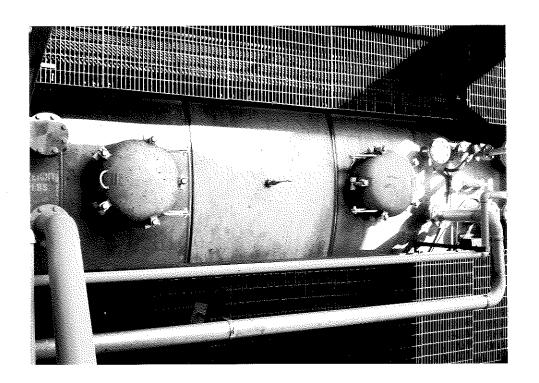
Photograph No. 1 Orientation:

History of Documented Releases:	No releases from this SWMU have been documented.		
Observations:	The tank farm is new. PRC observed no cracks in the tank farm containment and no evidence of release. The roof would appear to

Description: Waste Fuel Tank in new fuel tank farm

PRC recommends no further action for this SWMU.

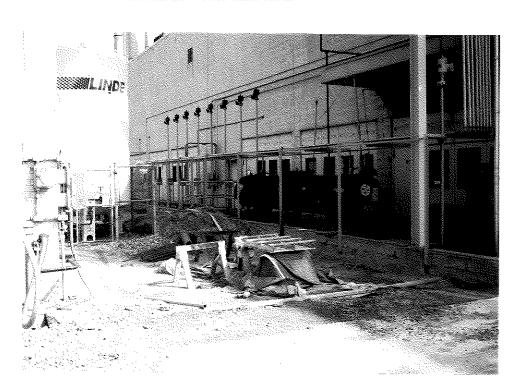
Photograph No. 2

This unit is located outdoors 50 feet north of the Former Fuel Tank Farm (AOC 1) and 10 feet southwest of the Waste Oil Tank. This 2,000-gallon underground tank measures 12 feet long by 5 feet 4 inches in diameter. Contaminated and waste fuels from testing activities are stored in this unit before being stored in the Waste Fuel Tank (SWMU 1). The unit is constructed of a stainless-steel inner tank, and a carbon-steel outer tank with a fiberglass coating (see Photograph No. 2).

The unit is underground. No evidence of release was observed.

pallet, and tarp. The Waste Oil Tank (SWMU 4) in the background straddles a

concrete trench

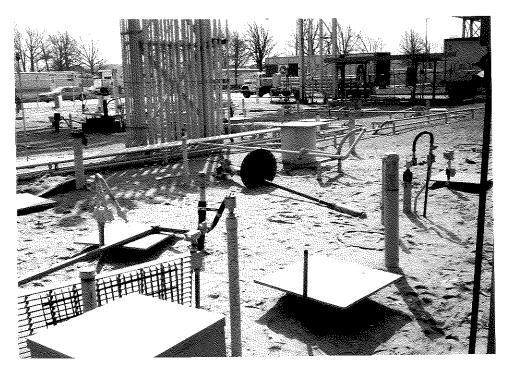
Photograph No. 3 Orientation: South

This unit is located outdoors in the northwest corner of the Former Fuel Tank Farm (AOC 1). This 2,000-gallon stainless-steel underground storage tank was used to store contaminated and waste fuels. The unit is empty and awaiting closure (see Photograph No. 3).

Description: The Former Waste Fuel Tank (SWMU 3) is visible in the foreground, beneath the

nearest plywood square. The Former Fuel Tank Farm (AOC 1) is in the background.

PRC recommends completion of closure requirements.

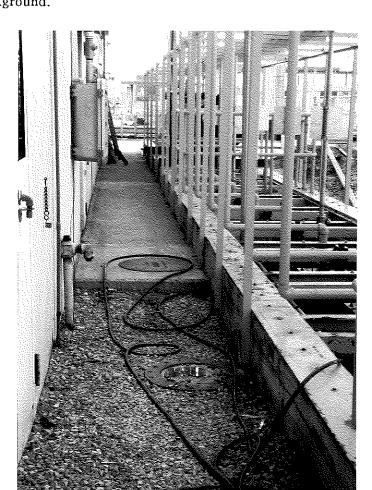
Photograph No. 4 Orientation: South

At the time of the inspection, the tank had been filled with sand, and its portal had been cemented shut. PRC observed no evidence of release.

Description: The Former Waste Oil Tank is located beneath the gravel in the foreground. Along the right edge of the photo is the concrete trench beneath the tank.

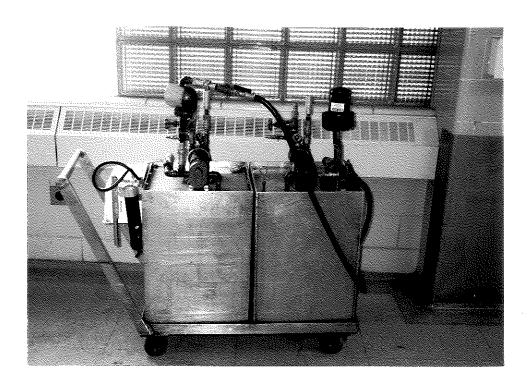
Photograph No. 5 Orientation: East

The cart observed during the VSI appeared to be in sound condition, clean, and sturdy.

Photograph shows a Mobile Oil-Changing Carts (SWMU 6). Waste oil is being poured into the tank on the right. Clean oil is dispensed from the tank on the left.

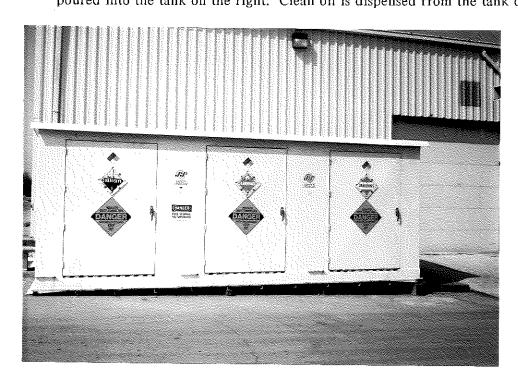
Photograph No. 6 Orientation: West

This unit is located outside. The unit is used to store all of the Davison facility's hazardous wastes generated from research and testing activities. Wastes include paint wastes (D001), waste mercury (U151), waste glycol, and various laboratory chemicals. The steel building measures 20 feet by 8 feet by 7 feet and can store about 20 55-gallon drums (see Photograph No. 6).

At the time of the inspection, hazardous and nonhazardous wastes were stored in the unit. PRC observed 20 55-gallon drums. One drum contained trash and was stored open, four drums were labeled "waste paraffin w/phenol," four were labeled "EDM waste," three contained paint-related waste, one contained thinner, one contained freon, and six could not be identified. In addition, one waste toner container was observed. No evidence of release was noted.

Description: The Hazardous Waste Storage Building Location: SWMU 7 Date: 03/26/92

PRC recommends analysis of unidentified waste on site.

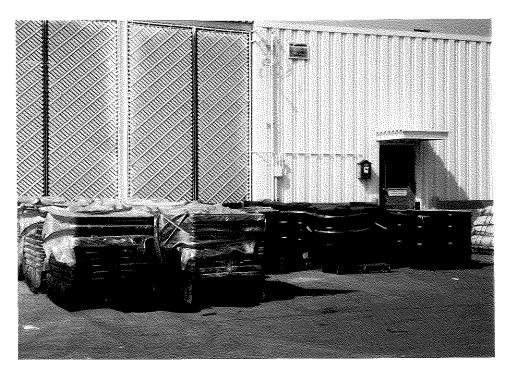
Photograph No. 7 Orientation: West

At the time of the inspection, the concrete pad area was almost full of product drums. The pole barn area contained paint products. PRC observed no cracks in either of the concrete floors. The building was in good condition, and PRC observed no evidence of release.

Approximately eight product totes and 30 55-gallon drums are stored outside on asphalt on the east side of the Former Hazardous Waste Storage Building (SWMU 8). Some of the drums contain contaminated soil and some contain contaminated water. All of the drums are stored on pallets. All of the totes contain soil and are covered with plastic. The wastes were generated during the ground-water contamination investigation at the Former Fuel Tank Farm (AOC 1). The materials are awaiting chemical analysis for final disposal (see Photographs No. 7 and 13).

background on the left. Containerized Soil and Water (SWMU 12) in totes and

drums are shown in the foreground.

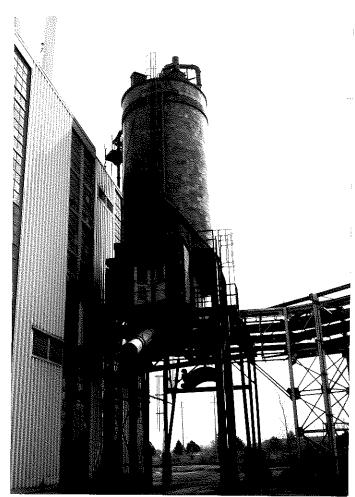
Photograph No. 8

PRC observed the unit from the ground and noted no evidence of release. However, releases may occur when hoppers emptied.

Description: Powerhouse Flyash Hopper

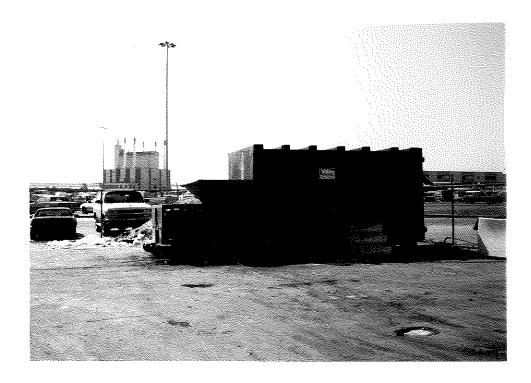
Photograph No. 9 Location: Orientation: South Date: 03/26/92

Description: Trash compactor; the powerhouse is shown in the background.

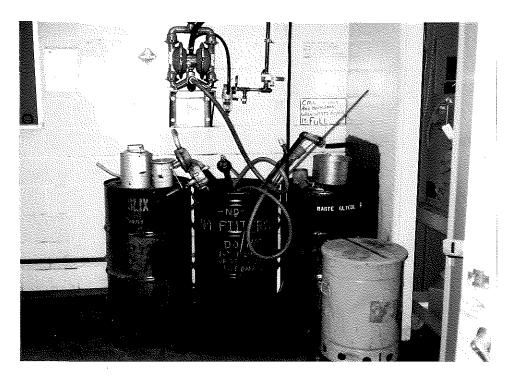
Photograph No. 10 Orientation: West

At the time of the inspection, the unit contained waste glycol and was less than half full. The room is big enough to contain a full spill, and the door to the outside has a threshold. PRC observed no cracks in the floor or evidence of release.

Orientation: West Date: 03/26/92
Description: Drums from left to right: Slix fire retardant, equipment for pumping oil to waste oil tank, waste glycol satellite accumulation area (SAA), covered container for dirty rags; the pump to the Waste Oil Tank (SWMU 4) is on the wall.

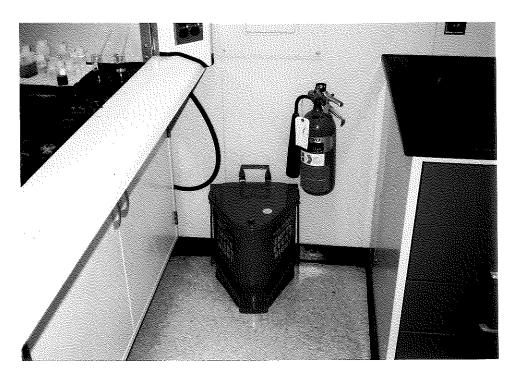
Photograph No. 11 Orientation: Wes

The unit PRC observed was in good condition. PRC noted no corrosion on the outside of the unit or evidence of release.

Description: Typical Laboratory Waste SAA

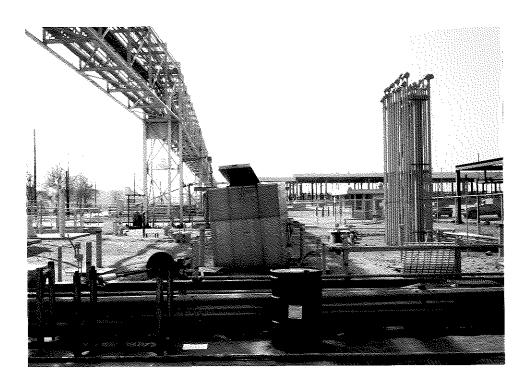
Photograph No. 12

During the VSI, facility representatives did not know what the drum contained or why it was stored in its present location. The drum was in good condition. PRC observed no evidence of release.

Bottom Drum (SWMU 13) is shown in the foreground. The roofed structure in the

far background is the new fuel tank farm.

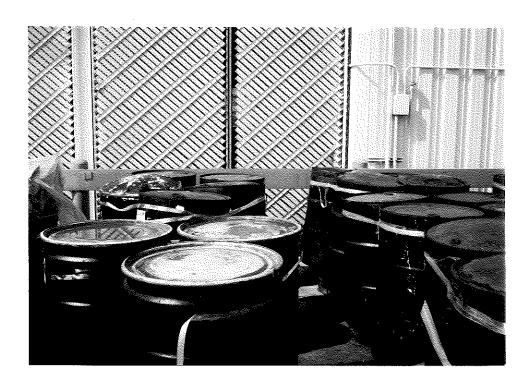
The drums and totes are stored on an asphalt surface. PRC observed some cracks in the asphalt near the storage area. Several of the drums are bulging, and one had a broken lid seam. According to facility representatives, the ground water in the drums froze and expanded, causing some of the drums to bulge and rupture. Many of the drums' sides and tops are rusty. Most drums are bound together with strapping tape and stored on pallets. PRC

West Date: 03/26/92
Photograph shows closeup view of containerized soil and water. Note rusting and bulging drums. Photograph No. 13 Orientation: West Description: Photo

PRC recommends ACR proceed with planned closure activities and soil and ground-water remediation. In addition, the containerized soil and water (SWMU 12) should be disposed of as soon as possible.
